CORROSION AND STRESS CORROSION SUSCEPTIBILITY OF SEVERAL HIGH TEMPERATURE MATERIALS

MDC E0609

Yearly Summary Report

MCDONNELL DOUGLAS ASTRONAUTICS COMPANY - EAST

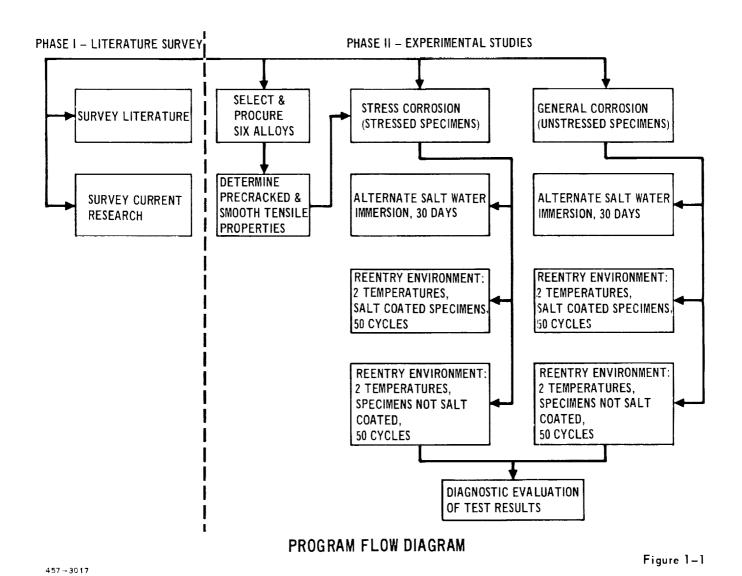
Ni-20Cr-2ThO₂ (TDNiCr) and R512E coated FS-85. Both unstressed specimens and fatigue-precracked stressed specimens of each alloy were exposed to alternate immersion in an aqueous salt solution and to temperature-reduced-pressure-time cycles which closely simulated the anticipated shuttle operating conditions. In the latter tests, some samples were coated with salt to study corrosion effects, and others were tested without a salt coating. Use of two sets of specimens aided in distinguishing corrosion and stress-corrosion susceptibility from other environmental effects. The program organization is summarized in Figure 1-1.

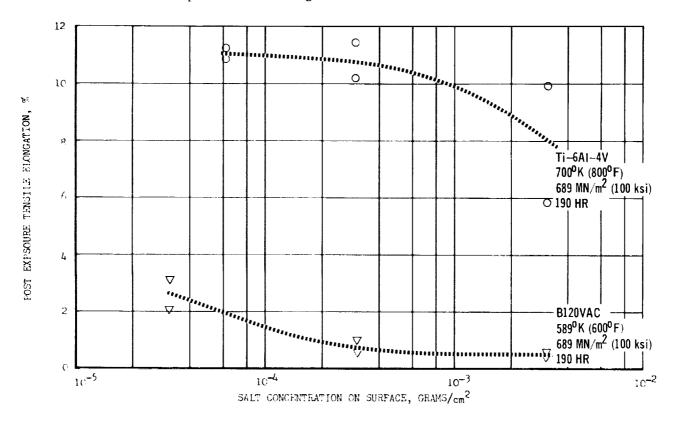
457 - 3024

EFFECT OF SURFACE SALT CONCENTRATION ON THE TENSILE ELONGATION OF SPECIMENS AFTER 190 HOURS ELEVATED TEMPERATURE EXPOSURE (REFERENCE 7)

example, in a program to study the effects of alkali-halide corrodents on the stress corrosion cracking of titanium alloys, Reference 7, it was found that the titanium alloys exhibited less ductility upon post-exposure tensile testing as surface concentration of salt is increased. The percent elongation of tensile specimens after 190 hours exposure at intermediate temperatures as a function of salt concentration is presented in Figure 2-1.

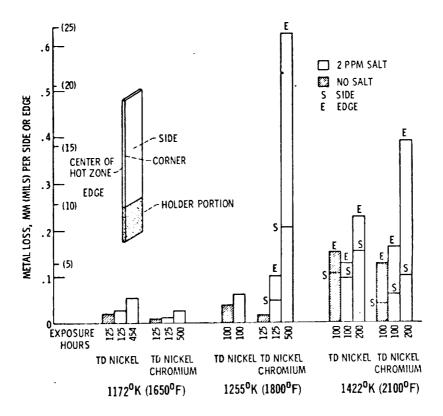
TEST CYCLE: 1 HOUR AT TEST TEMPERATURE, 3 MINUTE FORCED AIR, COOL TO ROOM TEMPERATURE.

HOT ZONE METAL LOSSES FOR TDNI AND TDNICT RESULTING FROM CYCLIC EXPOSURE IN SIMULATED ENGINE ENVIRONMENT (REFERENCE 13)

A similar program, Reference 13, evaluated the corrosion resistance of TDNi and TDNiCr in an environment consisting of a Mach 0.5 gas stream of A-1 jet fuel combustion products containing 2 ppm simulated sea salt. Sheet specimens with a thickness of 1.52 mm (.060 in.) were cycled up to 500 times between room temperature and test temperatures of 1172°K (1650°F), 1255°K (1800°F), or 1422°K (2100°F). Hot zone metal losses for each test condition is shown in Figure 2-2. Both alloys were found to be susceptible to hot corrosion attack at 1172°K (1650°F) and at 1255°K (1800°F). No evidence of hot corrosion was found after the 1422°K (2100°F) testing although TDNiCr lost 0.10 mm (4 mils) per side by oxidation. Edge attack was exaggerated in all cases and was attributed to a geometrical effect.

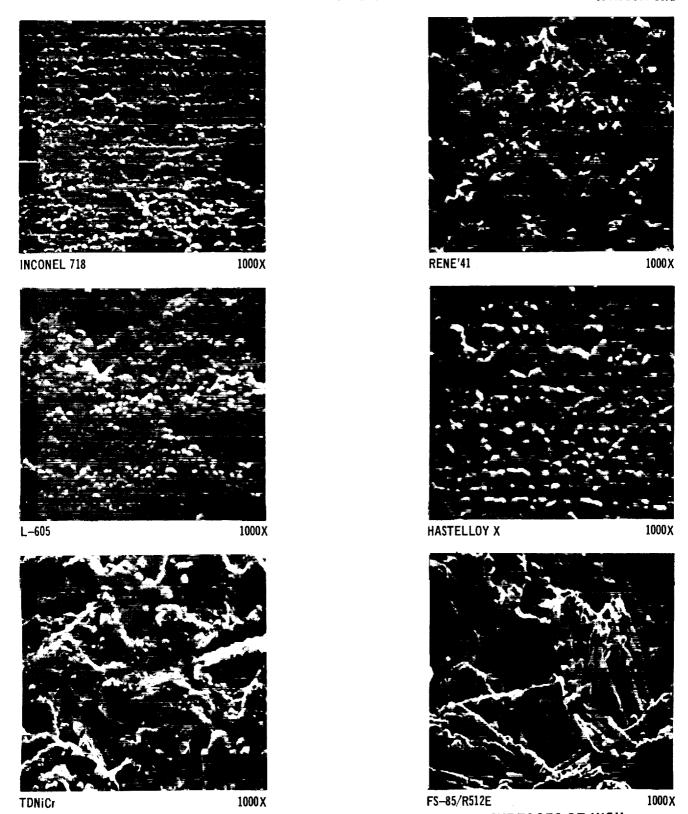
Figure 3-1

SCANNING ELECTRON MICROSCOPE PHOTOGRAPHS OF THE SURFACES OF HIGH TEMPERATURE ALLOYS AFTER FINAL HEAT TREATMENT

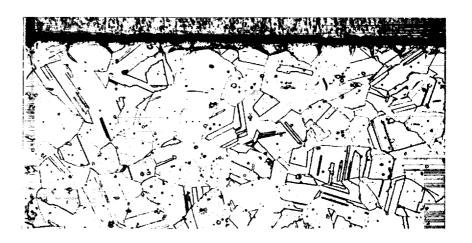
457-3035

> ETCHANT HCI + H₂O₂ MAG. 250X

MICROSTRUCTURE OF HIGH TEMPERATURE MATERIALS AFTER HEAT TREATMENT

The microstructures that occur as a result of heat treating at the temperatures specified in Table 3-2 are presented in Figure 3-2. The precipitation strengthened alloys such as Inconel 718 and Rene' 41 are characterized by precipitation of carbides. The fact that the Rene' 41 alloy shows a subsurface zone depleted of precipitates is attributed to the oxidation that occurred during the final heat treatment of the material. TDNiCr, a dispersion strengthened alloy, is characterized by very large directional grains and a fine dispersion of thoria. The recrystallized layer at the surface of the alloy was formed during the heat oxidation treatment as a result of the plastic deformation induced during roll-leveling the sheet. The columbium alloy FS-85 is shown with the intermetallic coating and diffusion zone. The columbium specimens were coated by Sylvania with

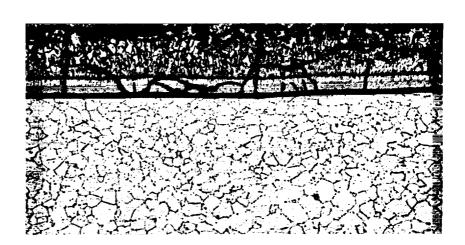
457-3037

FS-85
COATED WITH FUSED SLURRY
SILICIDE R-412E
1689⁰K-1 HR
ETCHANT
HNO₃
HF
LACTIC
MAG. 250X

MICROSTRUCTURE OF HIGH TEMPERATURE MATERIALS AFTER HEAT TREATMENT (Continued)

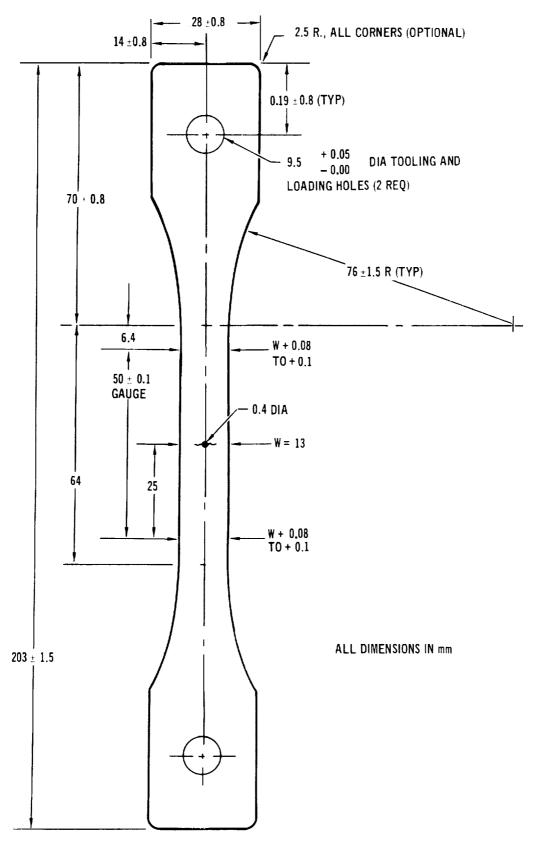
PRECRACKED TENSILE SPECIMEN

Precracked fracture toughness specimens came to be used in the study of such slow crack growth mechanisms as stress-corrosion. The use of such specimens led to the discovery (Reference 17) in 1964 that certain titanium alloys, previously considered immune to stress-corrosion in aqueous environments, failed catastrophically after short exposure times when fatigue cracked prior to loading. Since the susceptibility of a given material to stress-corrosion might be increased by the presence of a crack, fatigue precracked specimens were used for this program to ensure reliable results when evaluating stress-corrosion susceptibility. A further advantage was gained by using a precracked sample in that the excessively long incubation period required to form a crack in a smooth specimen was avoided without compromising the validity of the test results. The center-cracked-tension specimen shown in Figure 3-3 was selected because the thin gage to be studied

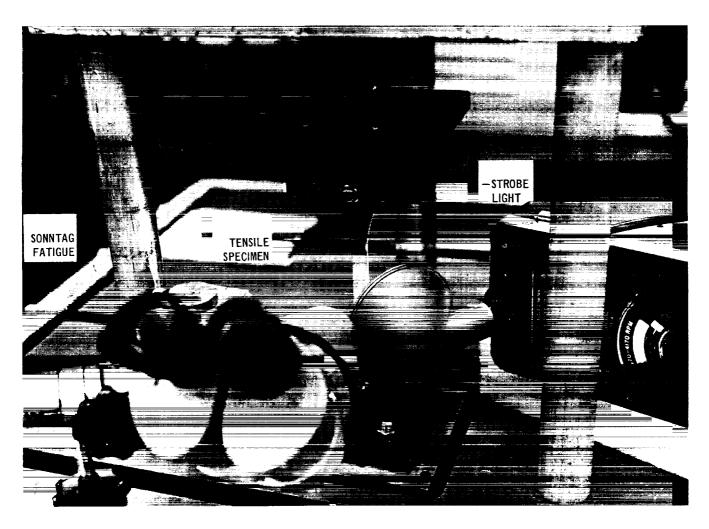
Figure 3-4

TENSILE SPECIMEN FATIGUE PRECRACKING APPARATUS

3.4 <u>Precracking of Tensile Specimens</u> - The precracking was accomplished by drilling a .254 mm (.010 inch) to .508 mm (.020 inch) starter hole through the center of the gage length of the specimen and then subjecting each to tension-tension loading at a stress ratio of 0.10 on the Sonntag SF-1-U universal fatigue testing machine shown in Figure 3-4.

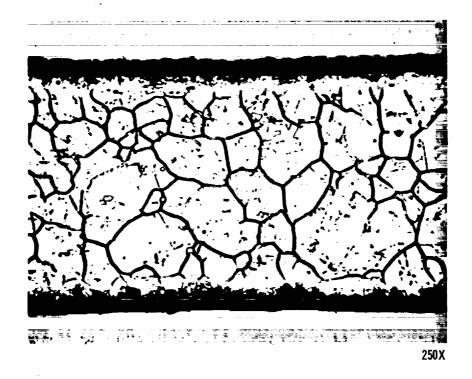
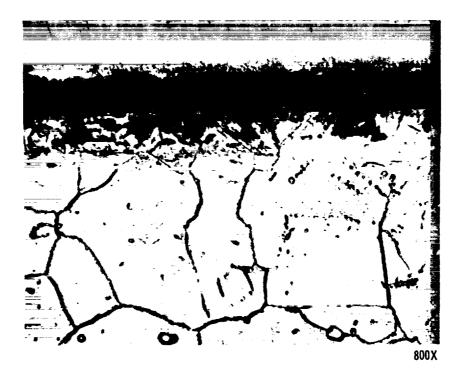
Figure 4-3 (b)

MICROSTRUCTURE OF RENE'41 UNSTRESSED CONTROL COUPON R-104 AFTER 60 DAYS ALTERNATE SALT WATER IMMERSION

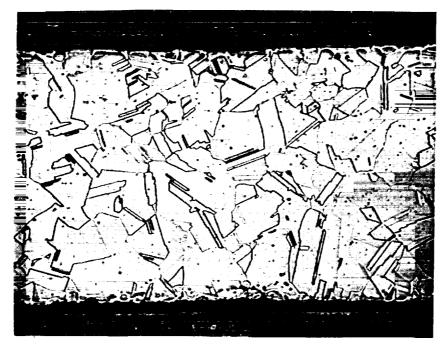
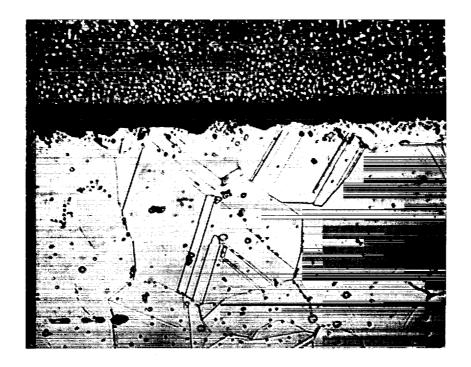
Figure 4-3 (c)

MICROSTRUCTURE OF L-605 UNSTRESSED CONTROL COUPON L-97
AFTER 60 DAYS ALTERNATE SALT WATER IMMERSION

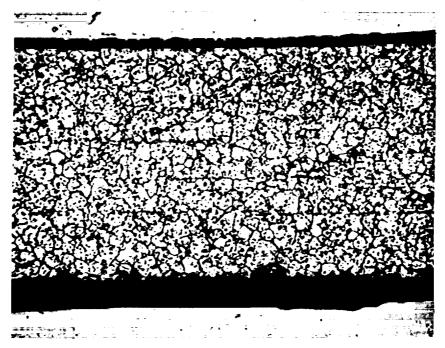
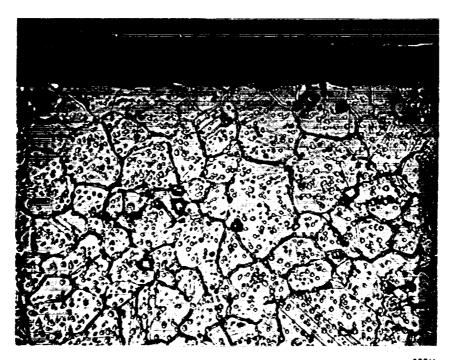
MICROSTRUCTURE OF HASTERLLOY X UNSTRESSED CONTROL SPECIMEN X-102 AFTER 60 DAYS ALTERNATE SALT WATER IMMERSION

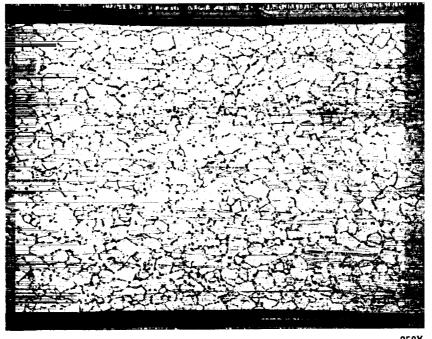
MICROSTRUCTURE OF FS-85 UNSTRESSED CONTROL SPECIMEN F-84 AFTER 60 DAYS ALTERNATE SALT WATER IMMERSION

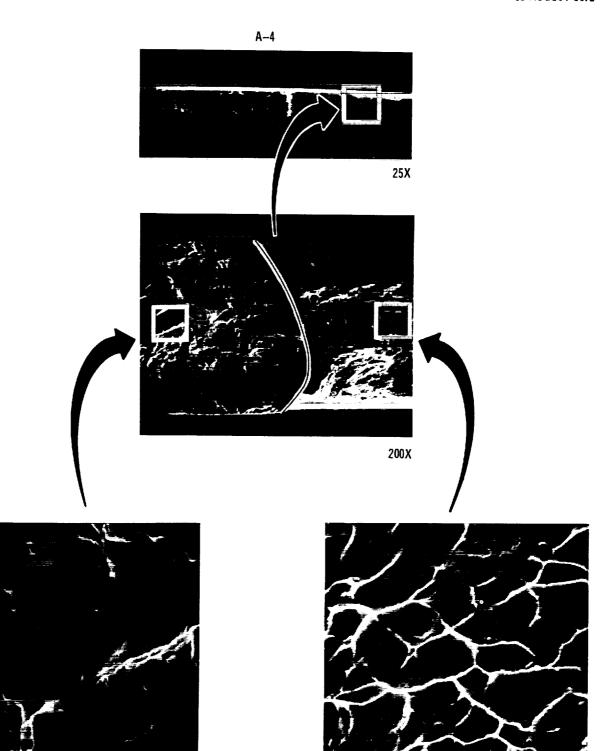
All of the tensile failure zones are of the dimple rupture type which characterizes a ductile material. During the fractographic examination of the specimens it was determined that the original crack length was longer than anticipated and, as a result, most of the precracked specimens were subjected to a net section tensile stress greater than 95% of the 0.2% yield strength. However, in no case were any of the specimens stressed more than 90% of their notched tensile strength. The actual net section stresses to which the specimens were subjected are presented in Table 4-3.

FRACTURE SURFACE OF INCONEL 718 SPECIMEN AFTER 60 DAY ALTERNATE IMMERSION TEST

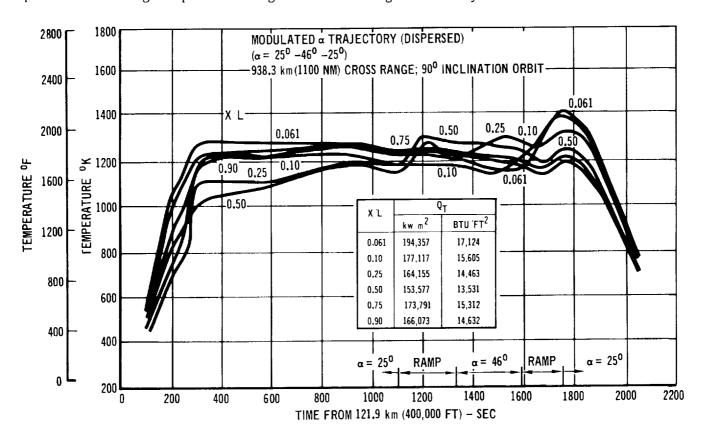
To accomplish this task an analysis was made of the delta orbiter trajectory taken from the McDonnell-Douglas Space Shuttle Phase B final report. The time-temperature history, presented in Figure 5-1, was determined by assuming that all local aerodynamic heating is rejected from the vehicle outer moldline by thermal radiation at each instant during entry. All temperatures were obtained considering an 0.8 surface emittance radiating to a cold sink. All of the time-temperature curves consist of an initial heat-up followed by an interval of modulating heating prior to heating drop-off during the later stages of entry.

DELTA ORBITER - BOTTOM CENTERLINE TEMPERATURES

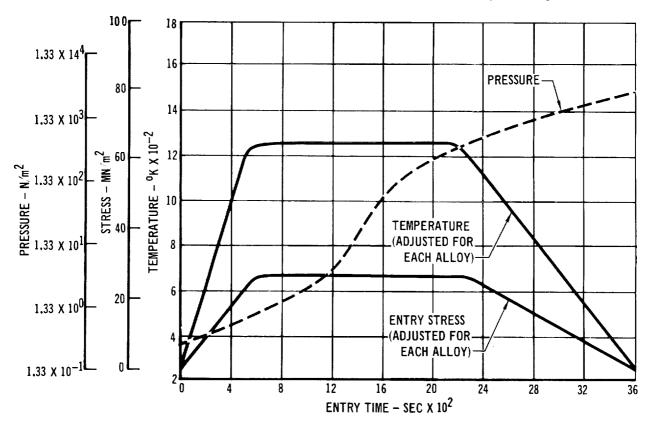
Figure 5-2

Since the trajectory evaluation will continue throughout the various phases of the Shuttle development, it was deemed appropriate to generate a simplified time-temperature curve which was not connected to any specific trajectory but emcompassed the most severe elements of any probable trajectory. The simplified curve was required to retain as much resemblance as possible to actual entry trajectories. With this objective in mind, a resultant time-temperature curve was developed. This curve, which is shown in Figure 5-2, is very close to the thermal profile of the Phase B Delta Orbiter (Figure 5-1) with respect to maximum time at temperature. The times required to reach maximum temperature and to cool down are different but this is due to the times required for furnace heat-up and cool down rather than to any specific change in trajectory rationale. During the actual testing of the high temperature materials the maximum temperature was adjusted to correspond to the maximum use temperature of the specific alloys being studied.

ENTRY TEST CYCLE

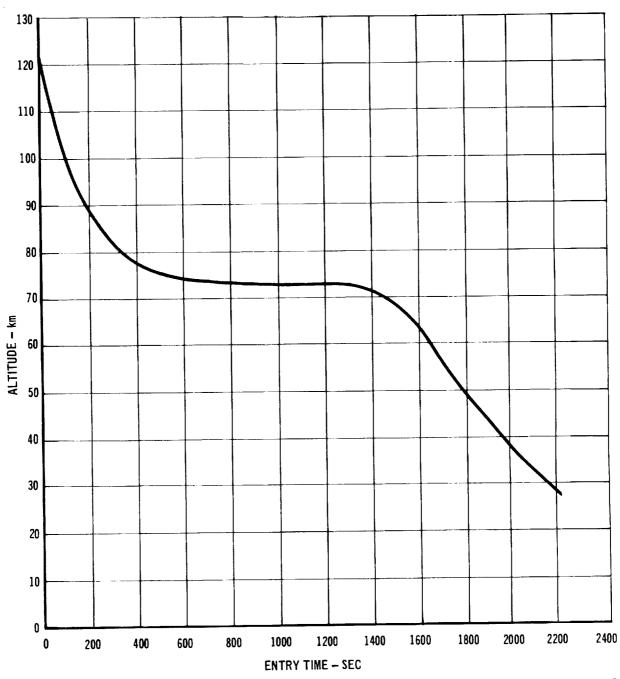
Figure 5-3

ENTRY TRAJECTORY FOR DELTA ORBITER

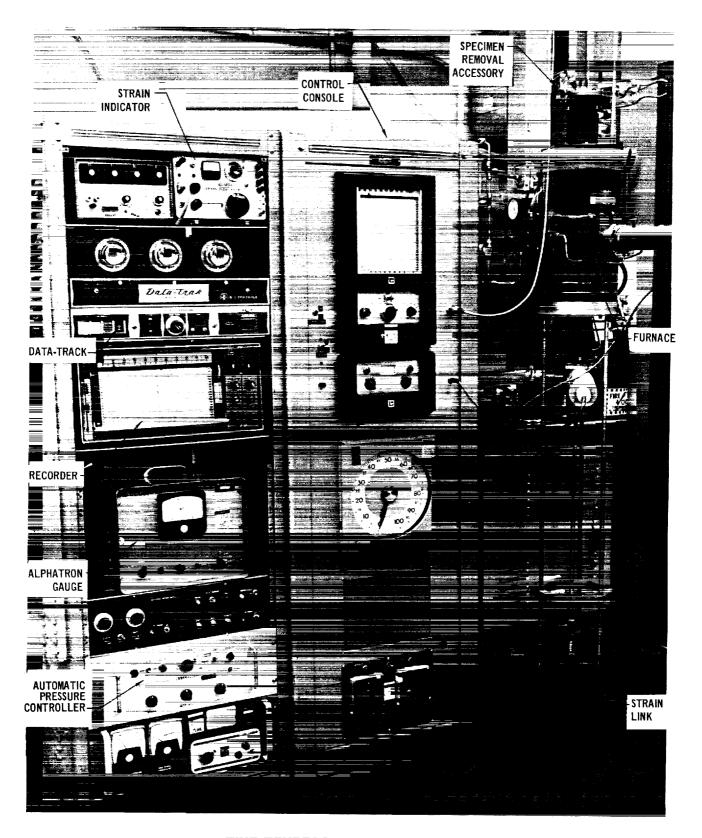
The equipment required for automatic pressure control includes an Alphatron vacuum gage and a pressure controller. The pressure is measured by a transducer in the Alphatron gage and converted into electric signals. These signals are monitored by the pressure controller, which compares them to the signals previously programmed on the Data-Trak. If there is a variation, the transducer will trigger a servovalve which will open or close as required to maintain the programmed pressure. An airflow rate of $16.4 \text{ cm}^3/\text{sec}$ (60 in 3/min) can be obtained at a pressure of $1.33 \times 10^3 \text{ N/m}^2$ (10 torr).

TIME-TEMPERATURE-PRESSURE-STRESS FACILITY

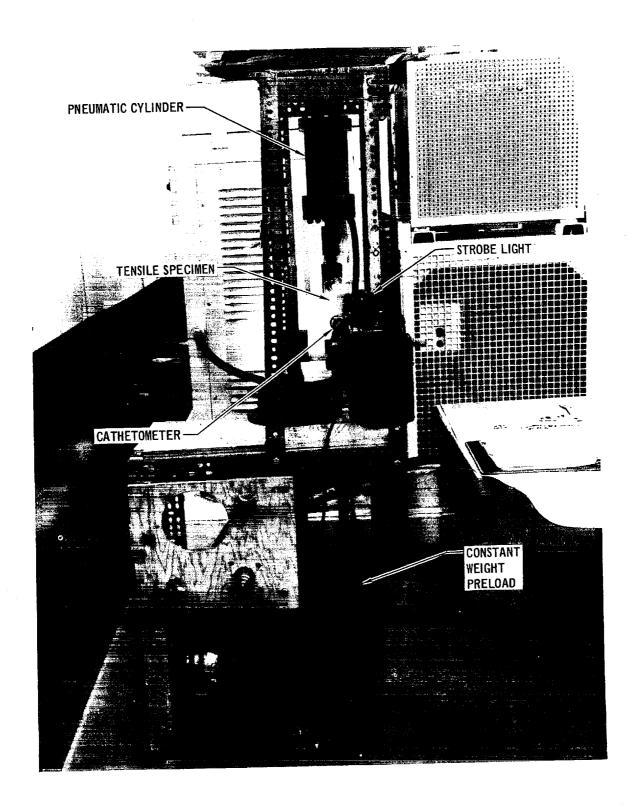
In the case of the columbium alloy FS-85, the specimen crack could not be observed directly because of the coating; however, the crack did propagate through the coating. The coating was suspected of cracking ahead of the base material because the ends of the cracks seemed jagged and appeared to follow the "grain boundaries" of the coating. 5-16

CRACK LENGTH MEASURING EQUIPMENT

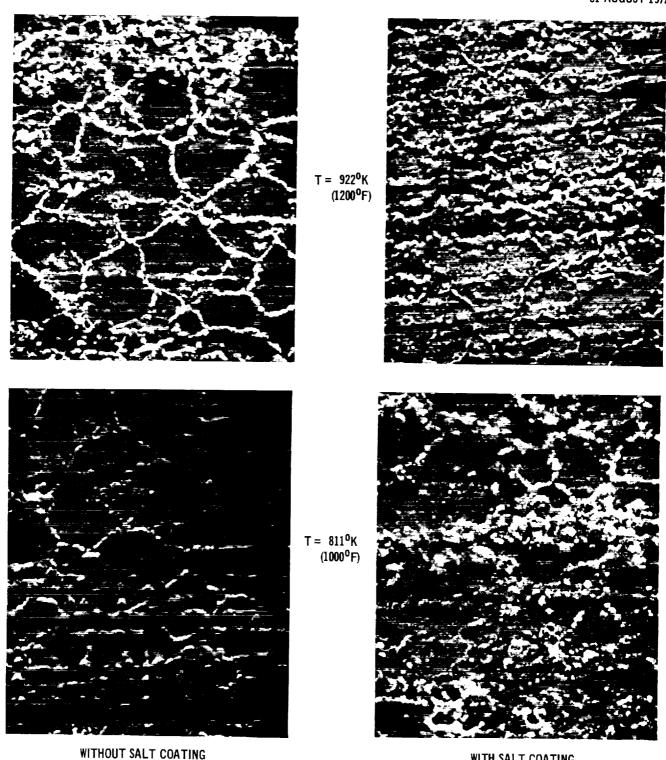
The fact that the salt coated specimens gained more weight than the uncoated specimens is in most cases due to the presence of residual salt particles not removed during the cleaning process. This conclusion is confirmed by the Scanning Electron Microscope photographs of Figure 5-9, showing the condition of the coupon surfaces after 50 simulated entry cycles. Besides confirming the presence of salt particles, these photographs also show that the surface of each salt coated specimen is nearly identical to that of its companion uncoated specimen. An exception

SCANNING ELECTRON MICROSCOPE PHOTOGRAPHS OF THE SURFACES OF INCONEL 718 TENSILE SPECIMENS AFTER 50 SIMULATED ENTRY CYCLES (1000X)

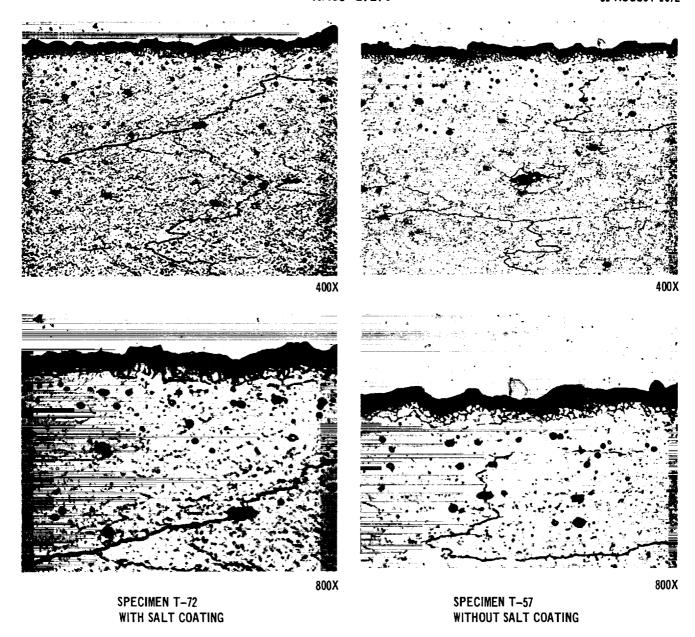
MICROSTRUCTURES OF TDNiCr SPECIMENS AFTER 50 SIMULATED ENTRY CYCLES AT 1366°K (2000°F)

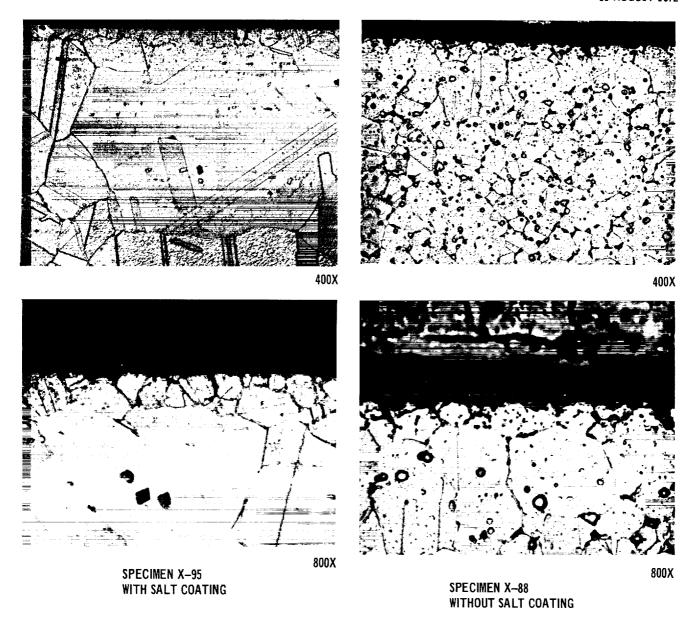
Similar but more pronounced microstructural phenomena are observed in the Hastelloy X specimens shown in Figure 5-14. All specimens exhibit a subsurface zone depleted of precipitates. For the specimens cycled to 1255°K (1800°F), this depleted zone is greater for the uncoated specimen than for the coated specimen,

MICROSTRUCTURES OF HASTELLOY X SPECIMENS AFTER 50 SIMULATED ENTRY CYCLES AT 1366°K (2000°F)

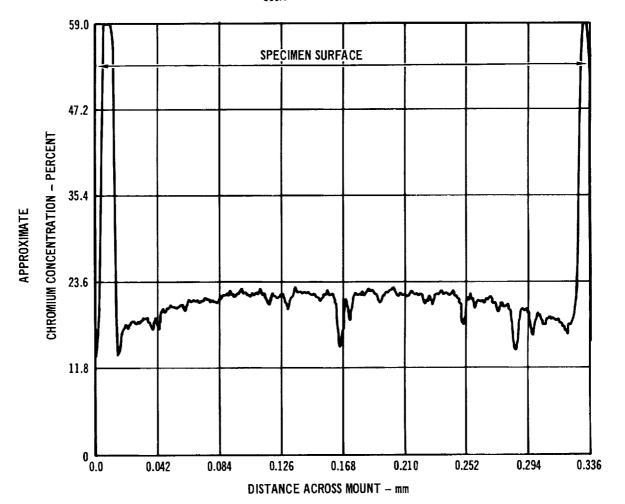
CHROMIUM X-RAY RASTER IMAGE AND MICROPROBE SCAN FOR HASTELLOY X SPECIMEN X-88 AFTER 50 SIMULATED ENTRY CYCLES AT 1366°K (2000°F), WITHOUT SALT COATING

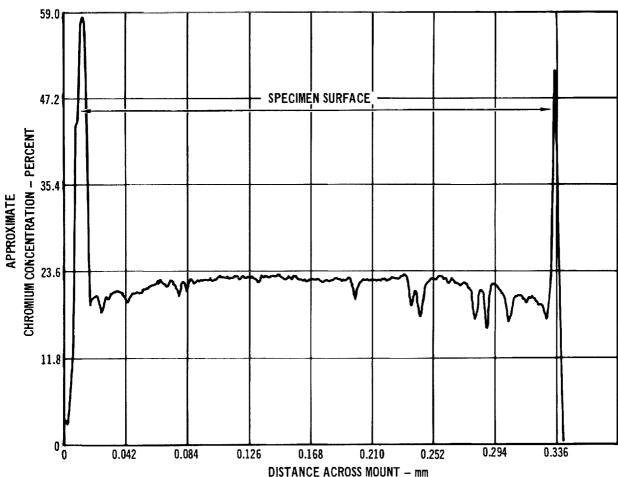
CHROMIUM X-RAY RASTER IMAGE AND MICROPROBE SCAN FOR HASTELLOY X SPECIMEN X-95 AFTER 50 SIMULATED ENTRY CYCLES AT 1366°K (2000°F, WITH SALT COATING

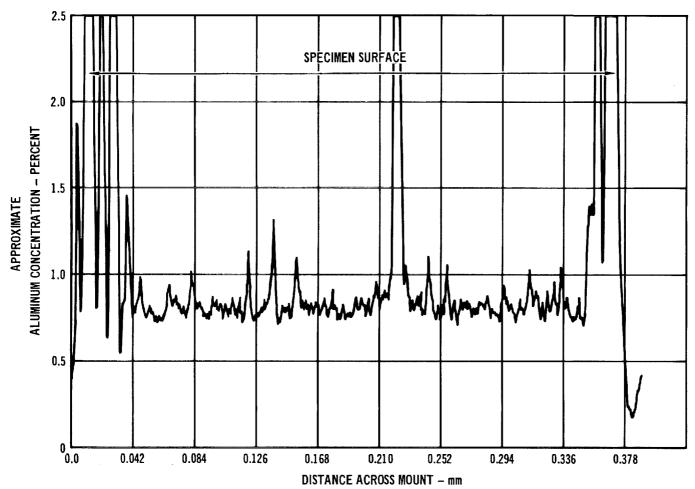
ALUMINUM X-RAY RASTER IMAGE AND MICROPROBE SCAN FOR RENE´41 SPECIMEN R-72 AFTER 50 SIMULATED ENTRY CYCLES AT 1144°K (1600°F), WITHOUT SALT COATING

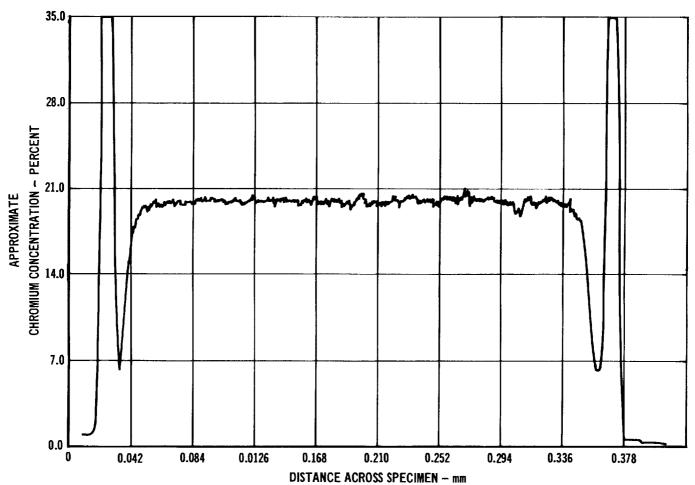
CHROMIUM X-RAY ROSTER IMAGE AND MICROPROBE SCANE FOR RENE'41 SPECIMEN R-72 (Continued)

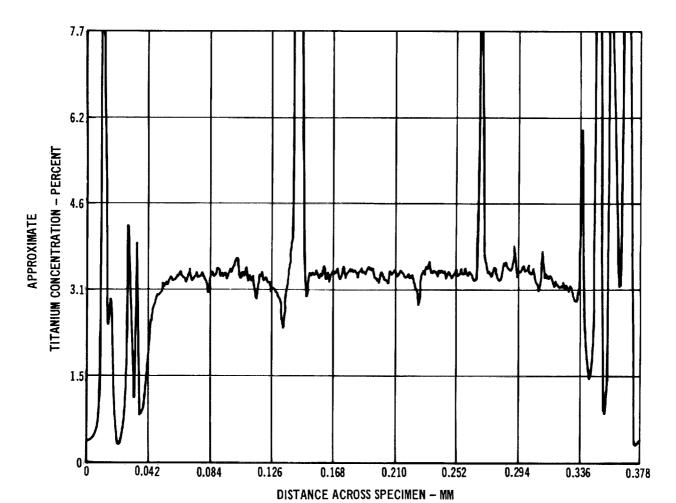
TITANIUM X-RAY ROSTER IMAGE AND MICROPROBE SCAN FOR RENE '41 SPECIMEN R-72 (Continued)

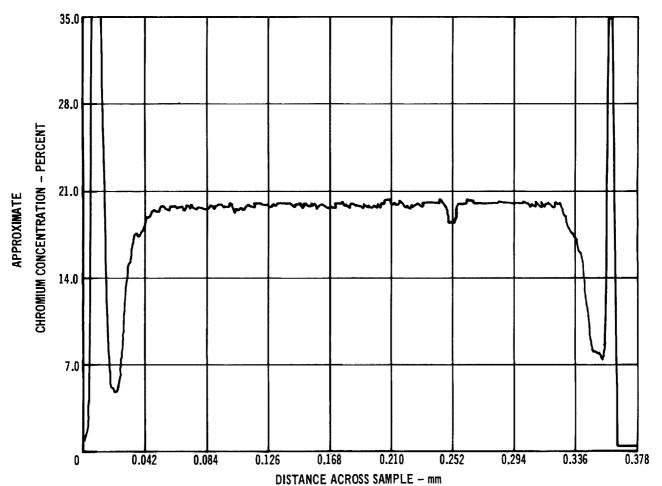
CHROMIUM X-RAY RASTER IMAGE AND MICROPROBE SCAN FOR RENE '41 SPECIMEN R-83 (Continued)

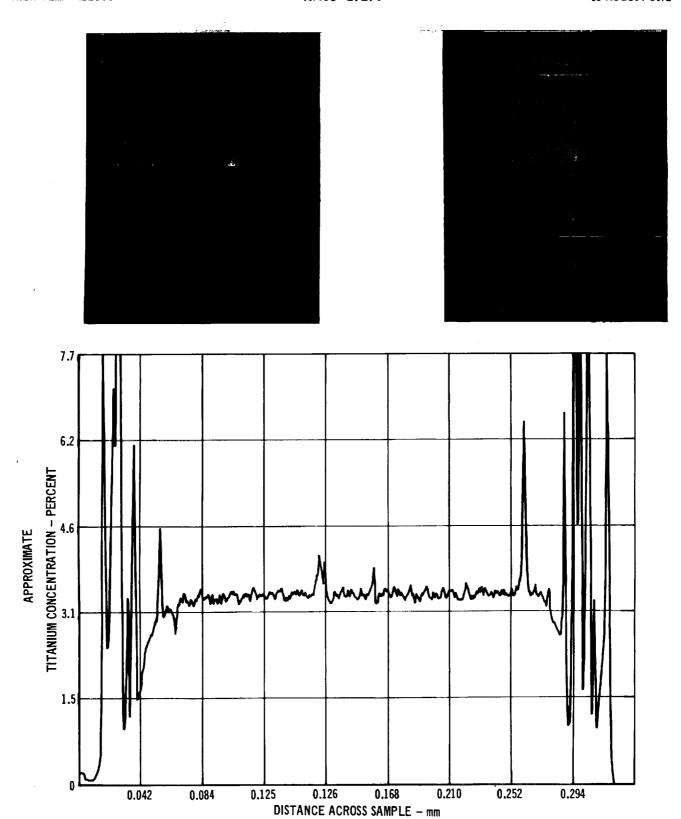
TITANIUM X-RAY RASTER IMAGE AND MICROPROBE SCAN FOR RENE '41 SPECIMEN R-83 (Continued)

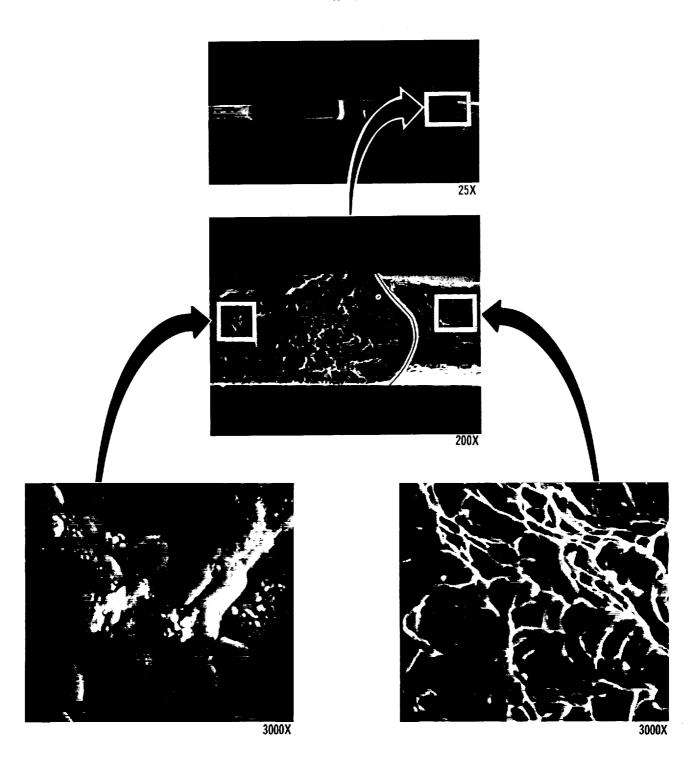
HASTELLOY X SPECIMEN AFTER 50 REENTRY CYCLES AT 1255⁰K (1800⁰F) – NOT SALT COATED Figure B-14

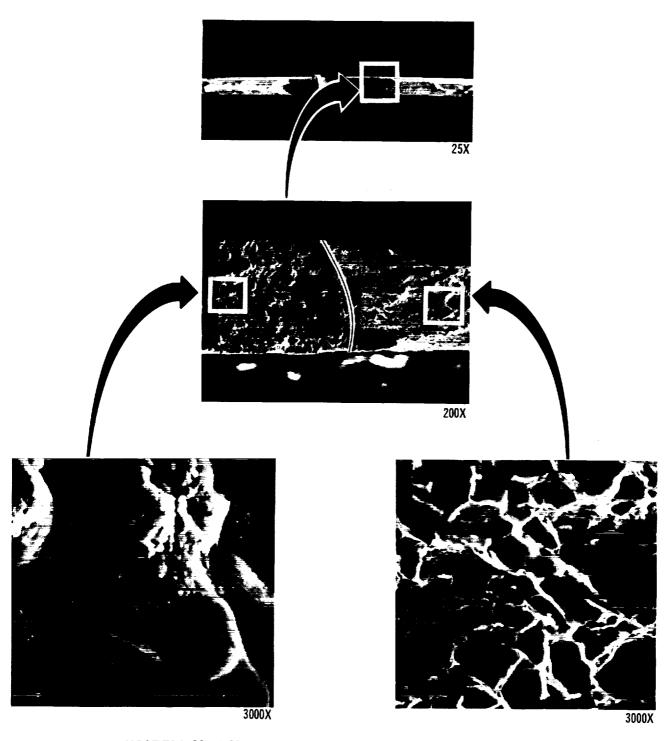
HASTELLOY X SPECIMEN AFTER 50 REENTRY CYCLES AT 1366°K (2000°F) — SALT COATED

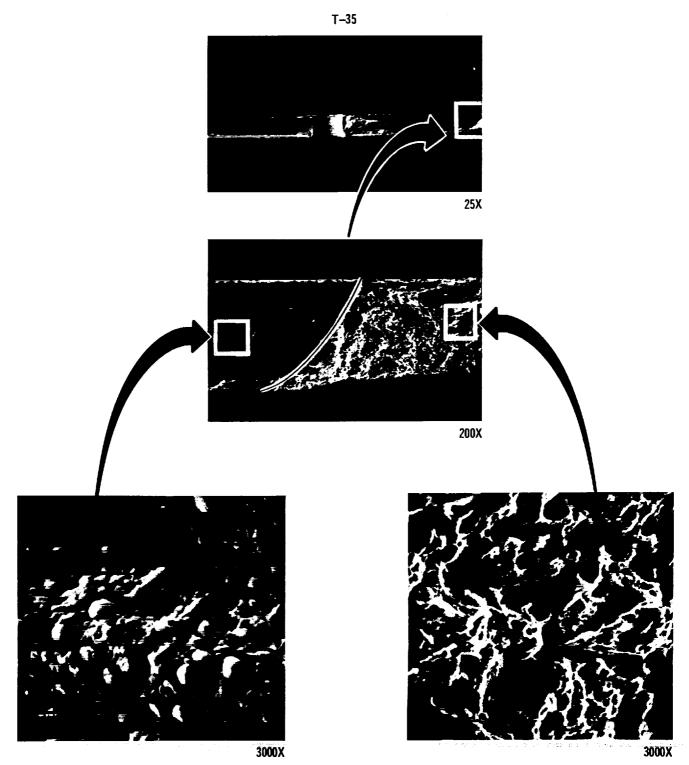
28 TD Ni Cr SPECIMEN AFTER 50 REENTRY CYCLES AT 1366°K (2000°F) - NOT SALT COATED

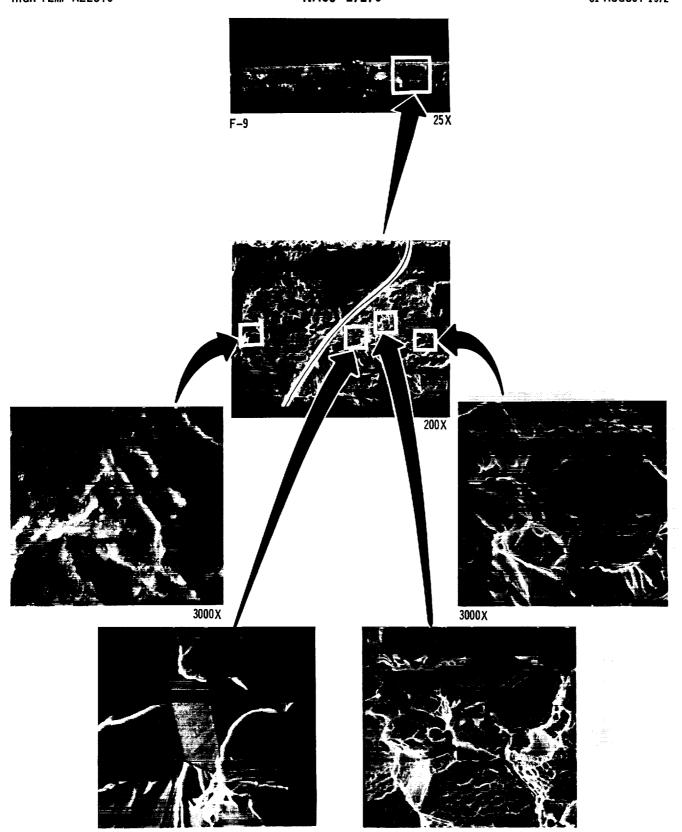
FS85 SPECIMEN AFTER 50 REENTRY CYCLES AT 1477°K (2200°F) - SALT COATED

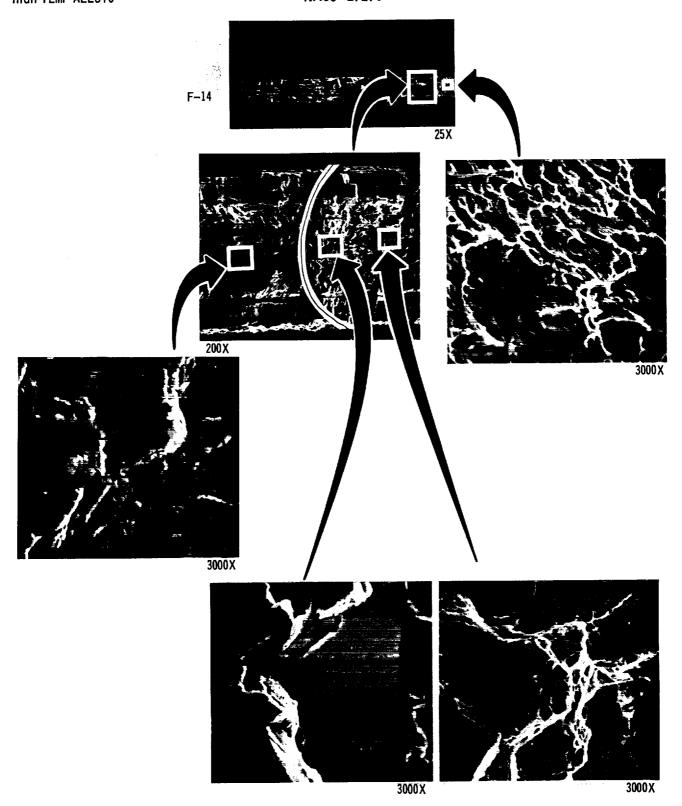
FS85 SPECIMEN AFTER 50 REENTRY CYCLES AT 1477°K (2200°F) - NOT SALT COATED

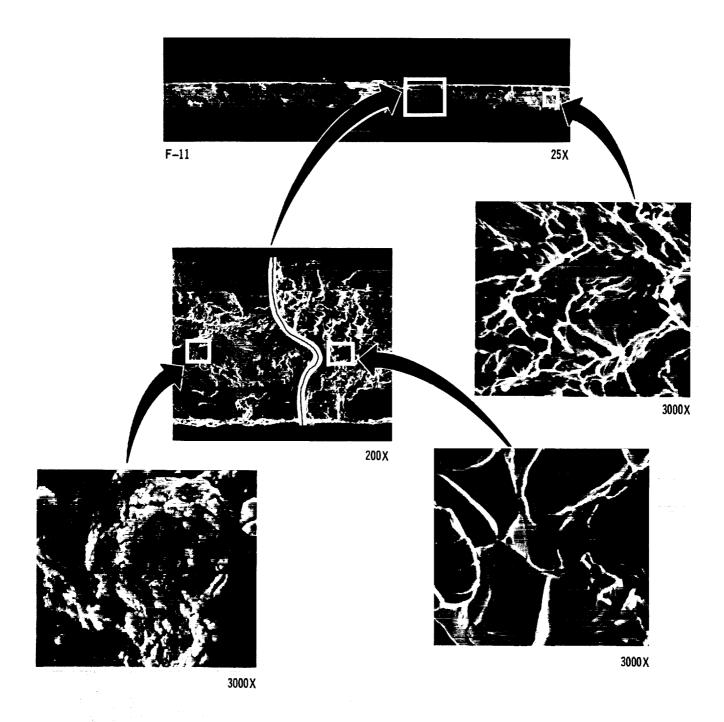
FS85 SPECIMEN AFTER 50 REENTRY CYCLES AT 15890K (24000F) - SALT COATED

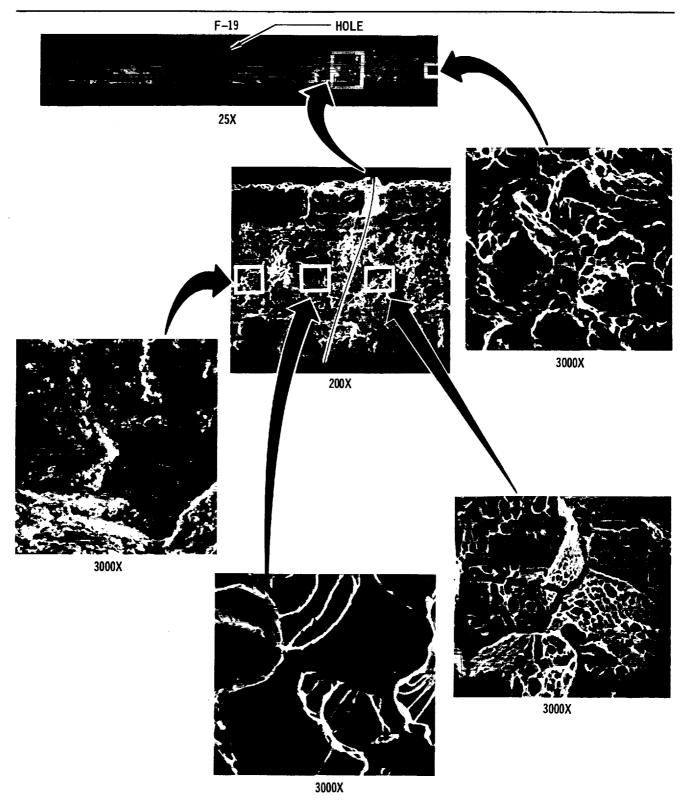
FS-85 SPECIMEN AFTER 50 REENTRY CYCLES AT 1589°K (2400°F)
- NOT SALT COATED
Figure
